Prepared By:
Home Performance Inspection PLLC
Snyder, TX 79549

Report Number:
2019

PROPERTY INSPECTION REPORT

Concerning: Texas
(Address or Other Identification of Inspected Property)

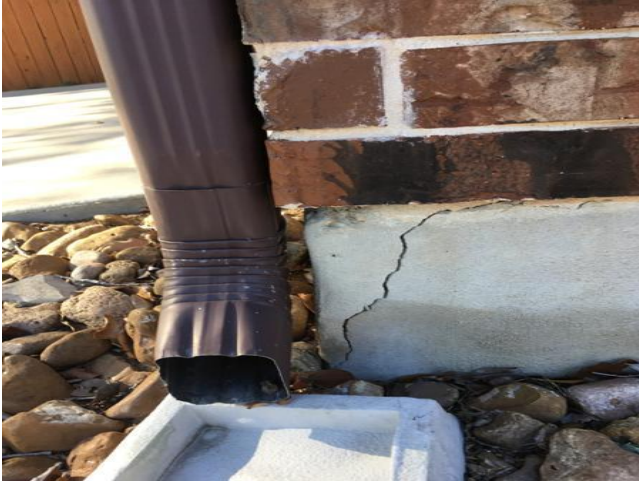
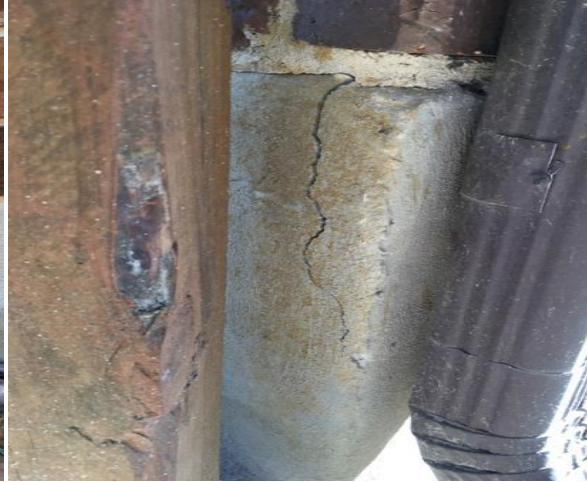
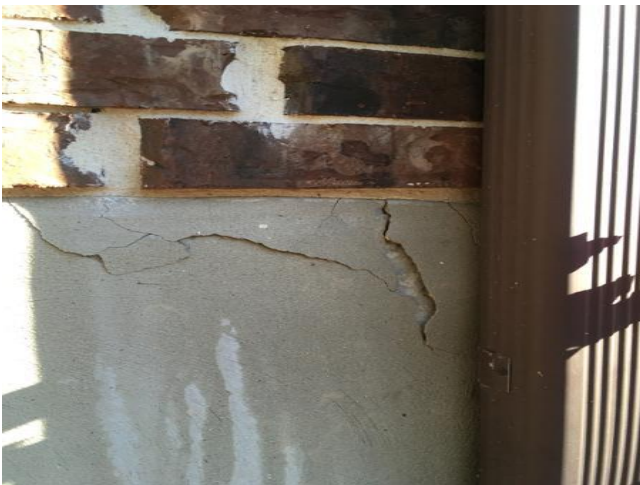
Corner pops on front right and left corners and rear right and left corners.

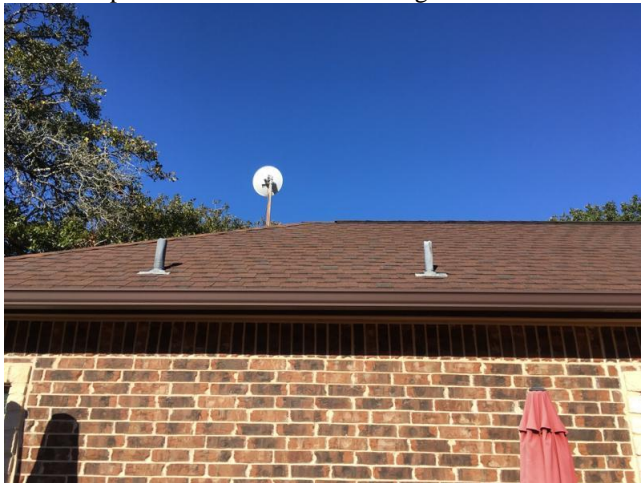
Rusted exposed nail heads need roofing cement.

Exposed nail heads at vent flashings should be sealed with roofing cement.

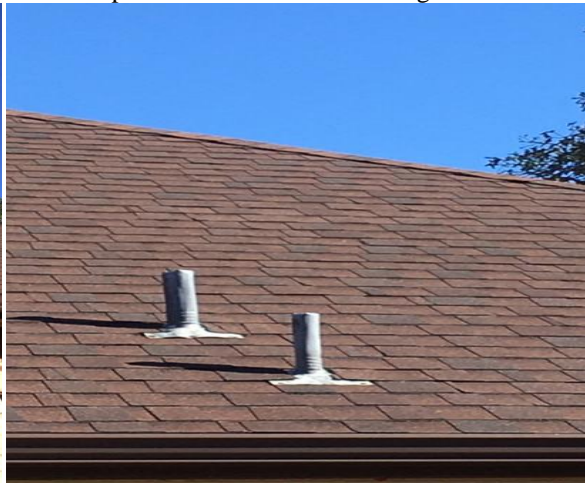
Rusted exposed nail heads need roofing cement.

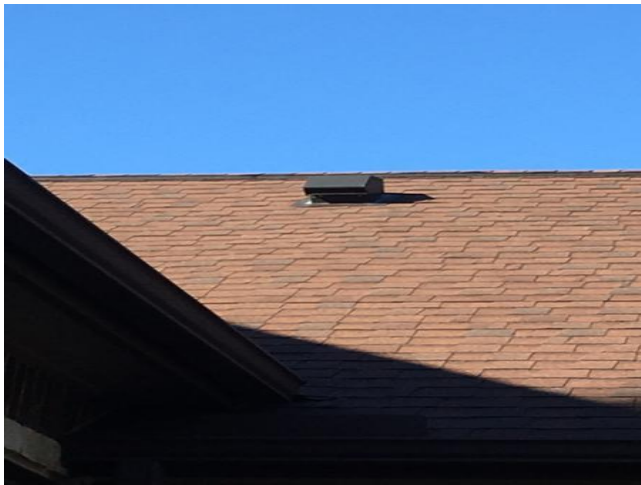
Needs kick out flashing at eve over hangs and side walls to prevent water from running down side of brick.

I think an extension piece on the stove vent will reduce water from entering the vent and dripping on stove in heavy wind driven rain.

Stove vent flashing needs looked at and possible extention to keep wind driven rain from entering vent.
Kick out flashing in lower left corner to direct water in gutter rather than down wall.

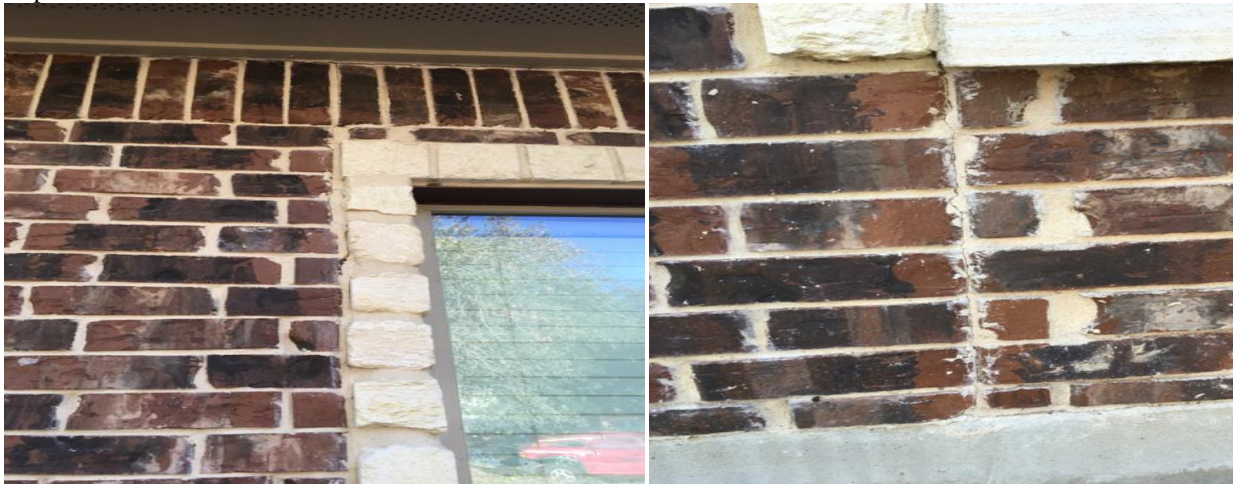
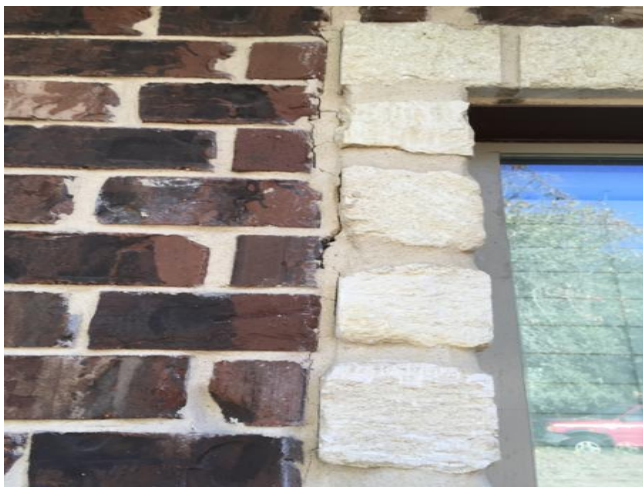
Exterior walls brick veneer with stone inlay.
Right side expansion joint has brick mortar cracking loose replace mortar and monitor for movement. Minor cracks were noted. This condition is mainly cosmetic in nature and should be patched.
Right side of garage door needs minor caulking. And top corner needs some mortar replacement in hole.

Expansion Joint With Lose Mortar

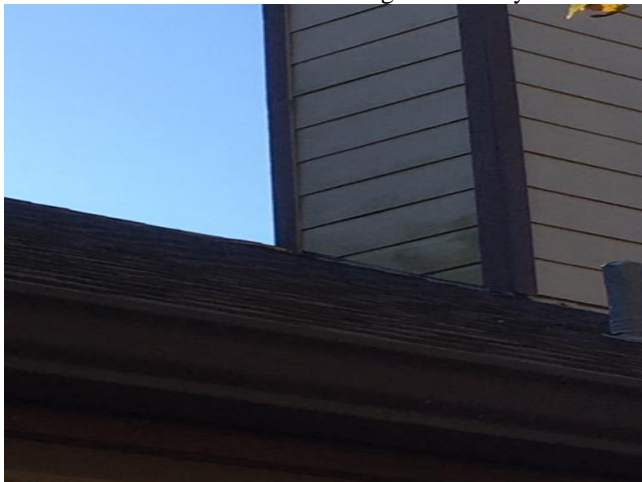
Mildew on lowernorth side of siding on chimney chase.

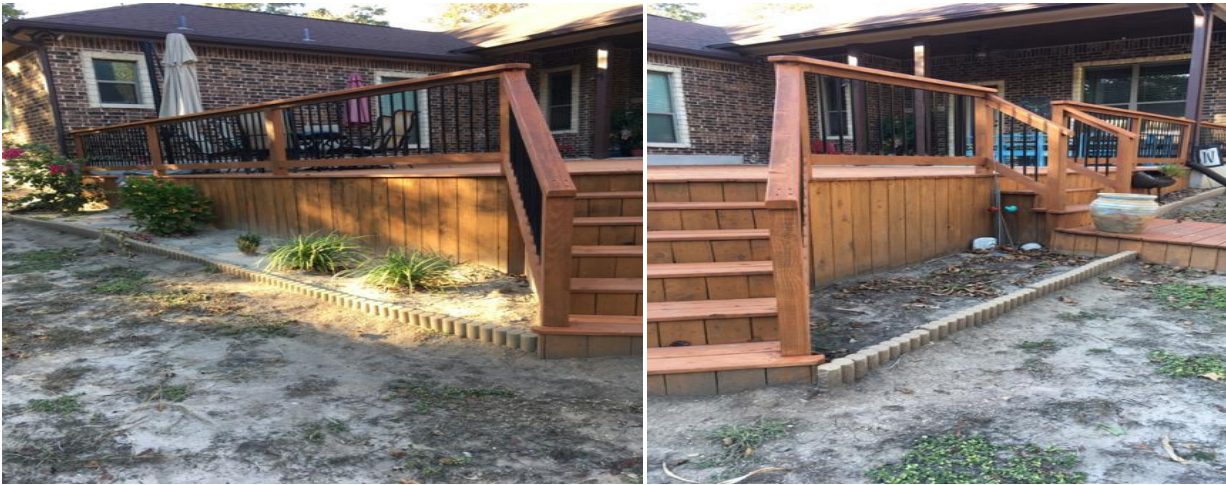
Surface crack in rear concrete porch.

Wood in contact with ground at deck area, possible cause of termite damage in later years.

I suggest a ground treatment of some sort for termite prevention.

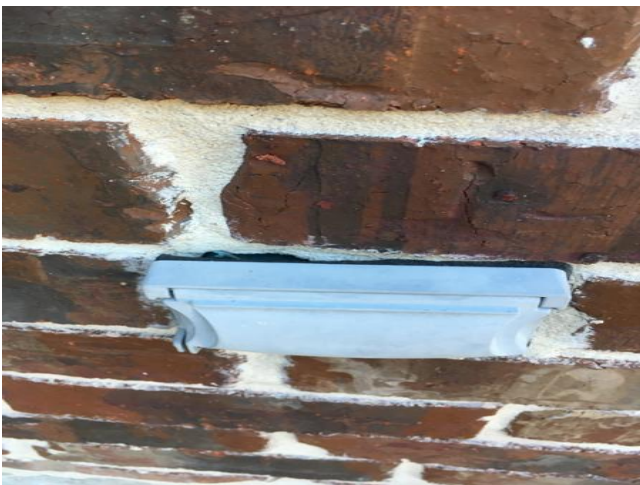
Rear outdoor plug by A/C unit needs caulked and sealed.

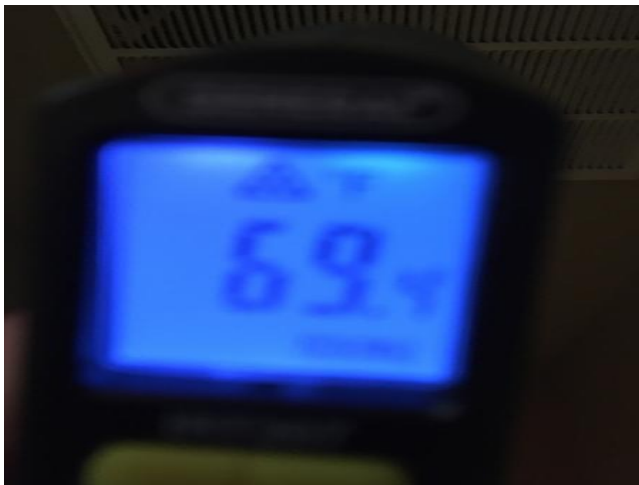
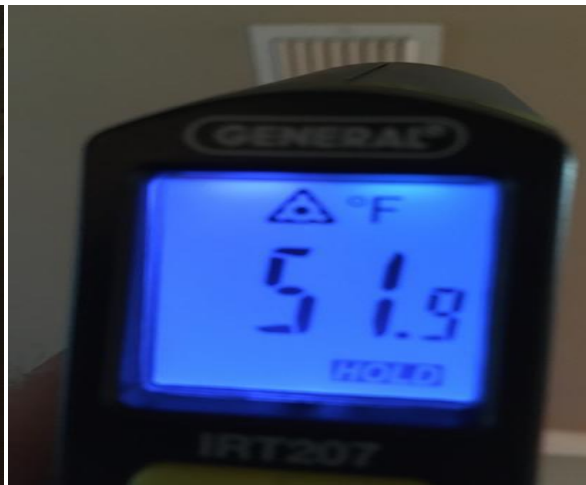
Return air was at 69.4 and supply air at 51.9 a 17.5 degree difference. Unit is clean and working properly.
